21st-century classic

Foster's design for a covered square in the heart of the British Museum meant the engineer had to sit 800 tonnes of steel and glass over the world-famous and grade I-listed Reading Room.

How the roof is supported by the existing structures

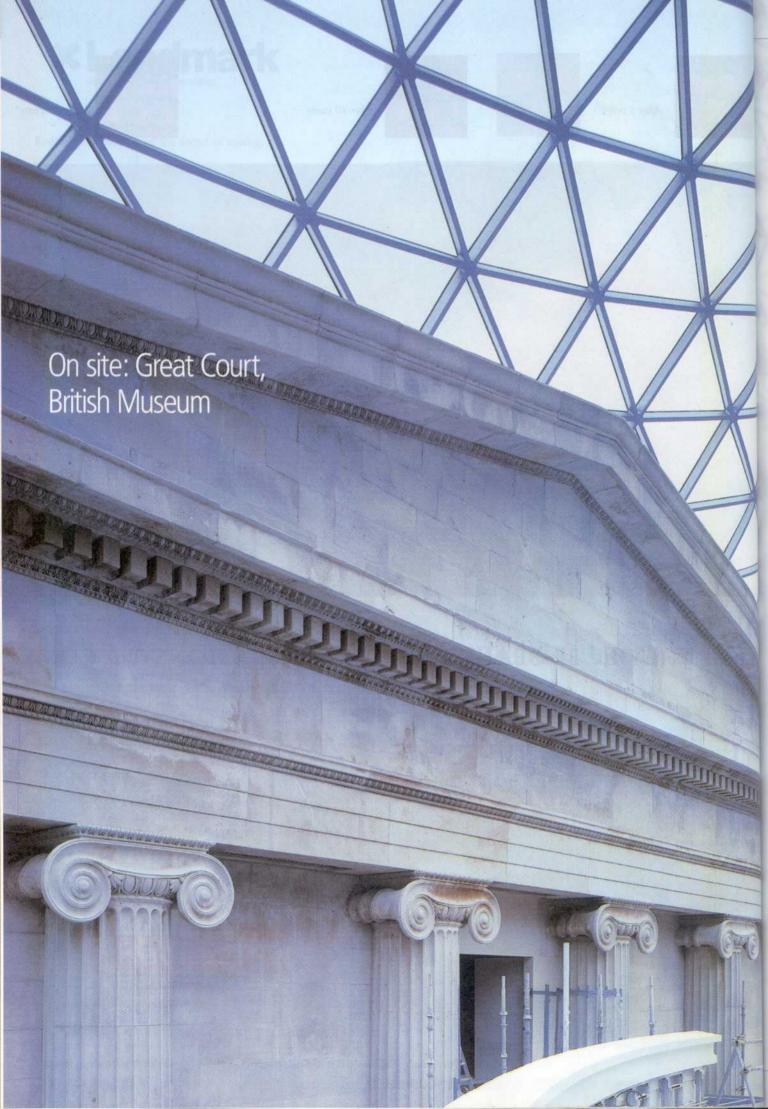
Above: CAD image showing the project as completed. Opposite: The outer edge of the steel and glass roof sweeps down to rest on reinforced concrete beams behind the parapets of the restored facades that line Sir Robert Smirke's 1852 courtyard.

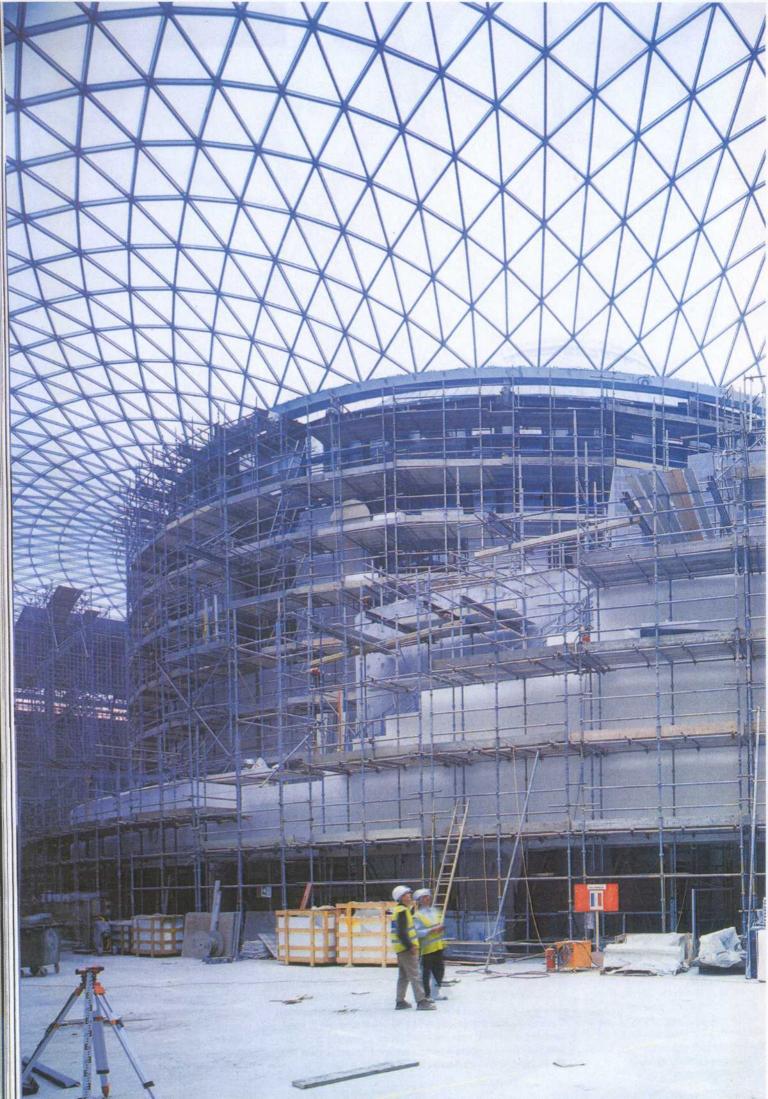
The magnificent lattice crowns the space between the Reading Room and the perimeter of the Great Court.

Scaffolding that supported the weight of the delicate-looking steel and glass roof during construction is slowly dismantled.

With the glazing installed, the roof weighed about 800 tonnes, all of which was carried by the temporary props, in turn supported by the scaffold platform. Before the platform could be dismantled, the props had to be carefully lowered until the roof sank gently onto its final resting place on the facades surrounding the square. "The de-propping sequence was agreed \textstyle="color: blue;">
• Very description of the property o

▶ by Buro Happold and Waagner-Biró. We had to make four sweeps around the 593 props, lowering each a fraction at a time," says Wright. "All the time the roof was being monitored to check that it was performing as the engineers had predicted." In the end, the roof dropped 150 mm and spread 90 mm laterally as it settled. "This was less than the engineers had predicted," says Wright, who was clearly relieved.

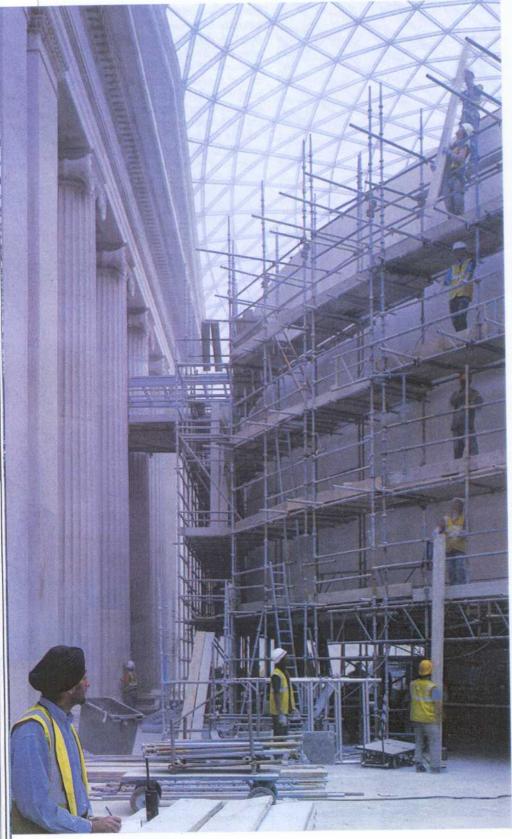
Restoration of the stone facades lining the Great Court. Stonemasons also reinstated an entrance portico removed in the 1870s.
